# **Demonstration of Remotely Operated Vehicles to Aid Underwater Inspection of Corps of Engineers Navigation Structures**

Winfield Locks and Dam 13—17 August 2007

James H. Lever and Gary E. Phetteplace

Final report

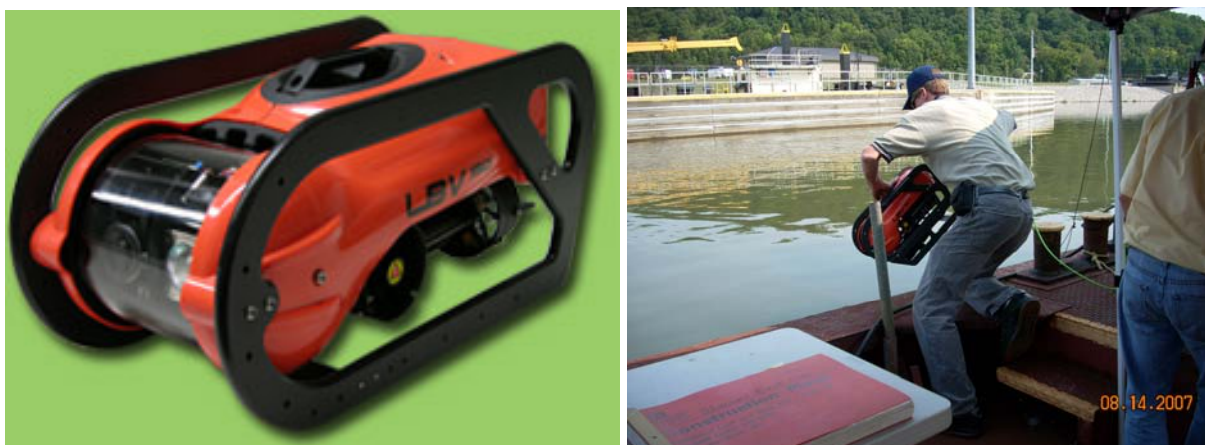
Figure 2. SeaBotix LBV150SE ROV (left) with color camera, black and white camera, and light mounted on tilt frame behind front cylindrical window, and one-person deployment/recovery (right).

Figure 2 shows the SeaBotix *LBV150SE* vehicle. As tested with sonar attached, it weighed about 13 kg and measured about  $0.53 \times 0.24 \times 0.35$  m. It has a tilting camera assembly consisting of a fixed-focal-length color video camera, LED lights, and a fixed-focal-length low-light black and white video camera mounted at  $70^\circ$  to the color camera. The BlueView P900E-20 imaging sonar was mounted horizontally on a skid under the

vehicle. The ROV uses two longitudinal thrusters for fore/aft propulsion, one thruster for vertical propulsion, and one thruster for lateral propulsion. Its depth rating is 150 m. Navigation aids include a fluxgate magnetic compass and a depth sensor. The compact topside system integrates an operator control unit with joystick to drive the vehicle, auto-depth and auto-heading functions, and a video display with data overlay. The tether is 0.76 cm in diameter. The system cost as tested was about \$26,300 exclusive of the sonar.
